Memo

Date: October 30, 2023

Re: Upper Baptist Hill Rd, Pine Hill Rd, Baptist Hill Rd Drainage Assessment

Existing Stormwater Drainage Infrastructure Assessment Pine Hill Road Neighborhood, Conway MA

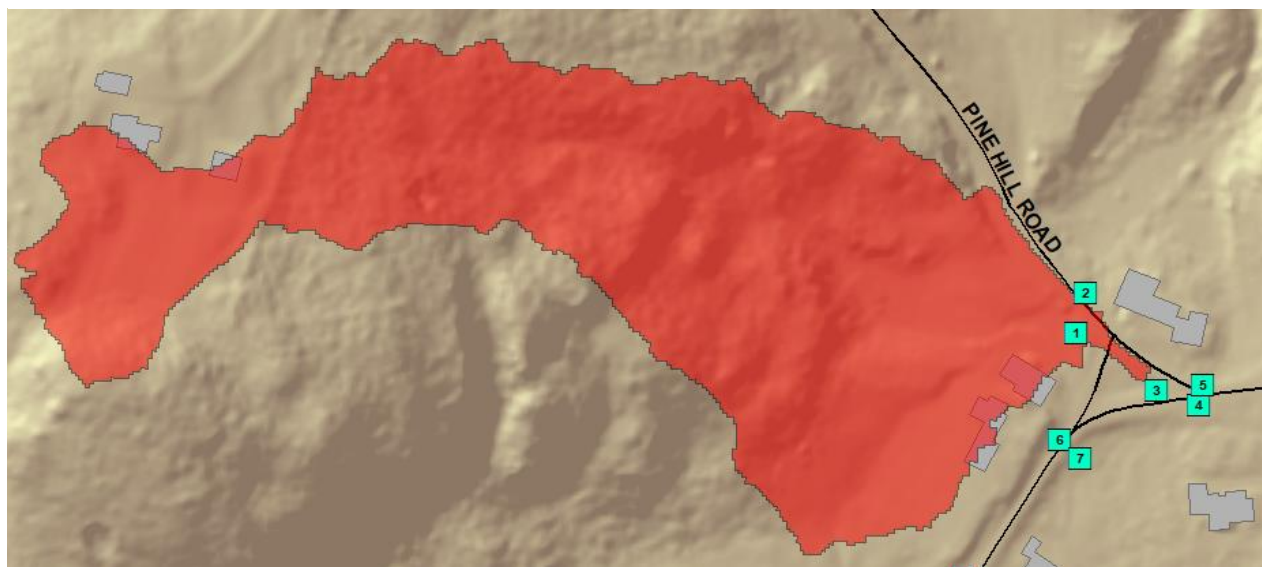
Figure 2. Estimated drainage area for culvert #3 on Pine Hill Road

The FRCOG conducted a GIS analysis to determine the size of the drainage area for culvert #1 on Pine Hill Road. The analysis showed that the watershed for this culvert is estimated at 10 acres, (see Figure 2) which requires a drainage pipe much larger than the current 16 inch culvert that is currently there.

- Increase the size of culvert #1 to a minimum of 20" and realign it so that water flows more easily into it
- Replace culvert pipe from #3 to #4 with a minimum 20" pipe

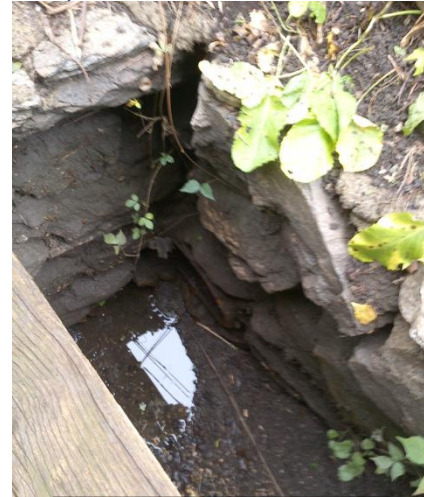
Figure 3. Culvert 4 (junction box)

There is a junction box located just past the traffic island at Pine Hill Road and Upper Baptist Hill Road (#4 on map) in which three pipes come together (1 buried and not visible – see Figure 3). FRCOG staff believe that the stormwater that is flowing from the traffic island through culvert #3 should be draining to this junction box and then flowing through a pipe to Baptist Hill Road. However, that pipe could not be located and is suspected to be crushed as town DPW have tried to unclog it without success. This junction box also has an overflow pipe to culvert #5, but because the outlet to Baptist Hill Road is buried and suspected crushed, all of the water instead flows to #5, which is undersized to accommodate the water volume causing more flooding at this intersection.

- Replace #4 junction box to a concrete box designed to handle the flow from Upper Baptist Hill Road
- Replace pipe from #4 to Baptist Hill Road
- Add additional drainage structures along Emerson Hollow Road to Baptist Hill Road

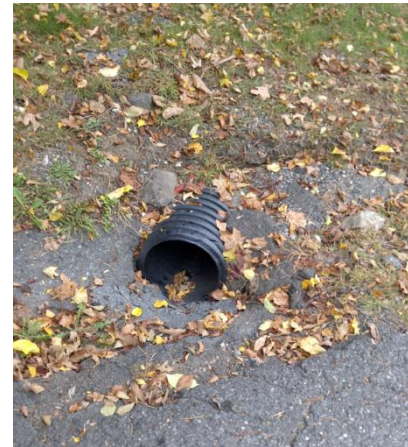
Figure 4. Culvert 16 (inlet)

From the intersection with Upper Baptist Hill Road, stormwater flows down Baptist Hill Road and is captured by three inlets. However, the drainage structures seem to end halfway down Baptist Hill Road at the drop inlet #15. It is not clear if there is an outlet there or where the stormwater then flows. There is a very small undersized pipe at #16 encased in asphalt (see Figure 4). There is also no evidence of any drainage structures on the connecting Emerson Hollow Road, which means that additional stormwater is flowing to Baptist Hill Road for only a few, small structures to handle that are easily overwhelmed during heavy rain events.

- If #15 is not adequately draining to Route 116, connect #15 to #16 and replace #16 to a larger size pipe.

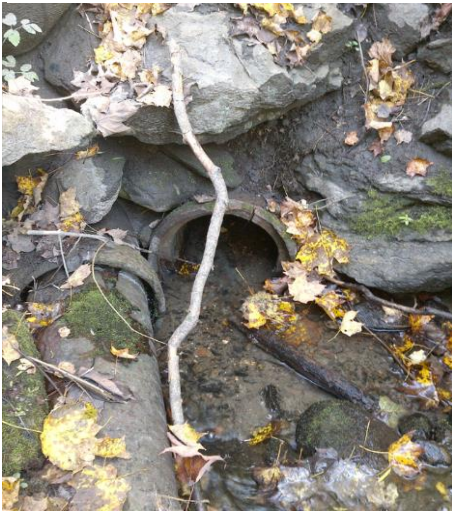
Figure 5. Two clay pipes at address 12 River Street

FRCOG's GIS analysis showed that much of the drainage in this area leads through the property located at the bottom of Baptist Hill Road and intersection with Route 116 (12 River Street). At this property, FRCOG staff found a clay pipe behind the house that seemingly drains directly from the north between Baptist Hill and Upper Baptist Hill Roads, but the inlet could not be located. Alongside this pipe was a second 12 inch clay inlet pipe that drains to Route 116 (see Figure 5 and 6).

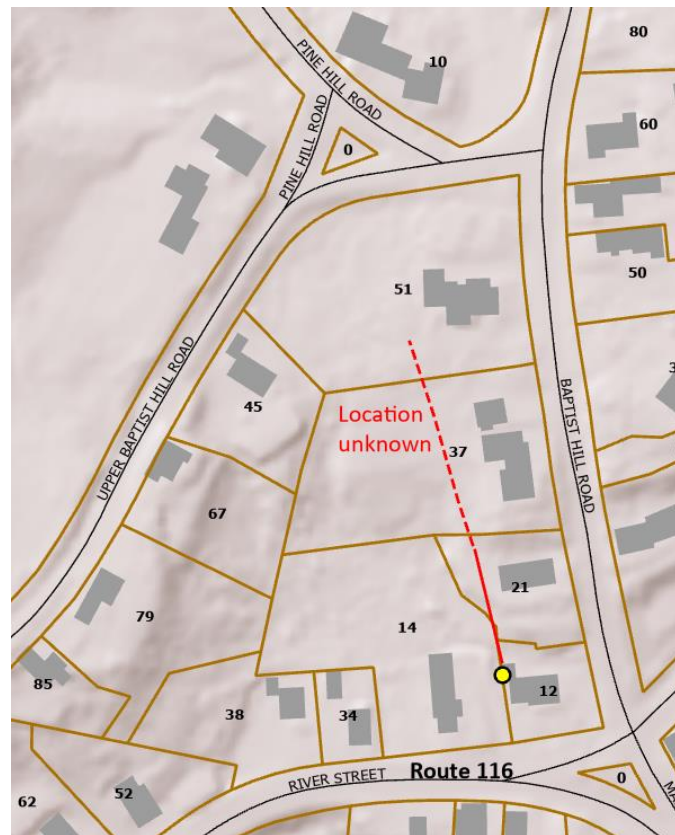
Figure 6. Area of unknown culvert pipe

GIS analysis shows that the drainage area of the unknown pipe at 12 River Street is approximately 24 acres. A drainage area of this size should have pipe with a minimum size of approximately 20 inches. (see Fig 7).

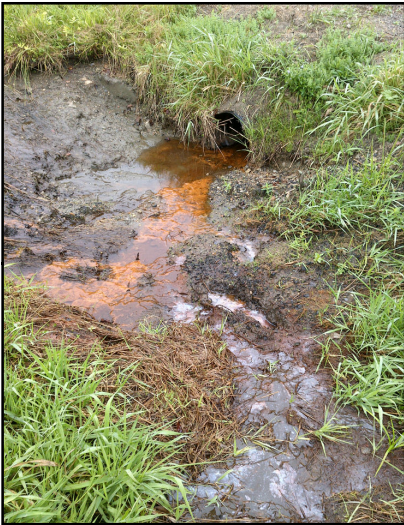
1

During the site visit, FRCOG staff identified two natural depression at culverts #1 and #3 which fill with water very quickly after the existing small pipes are overwhelmed with the quantity of
