2023 South River Walk and Watershed Tour

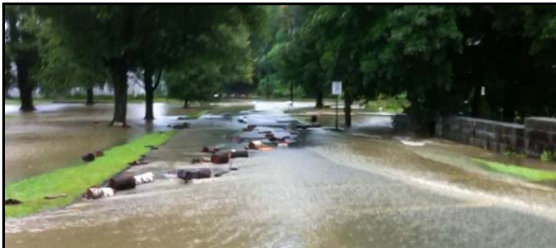
Tropical Storm Irene - View north up Elm St

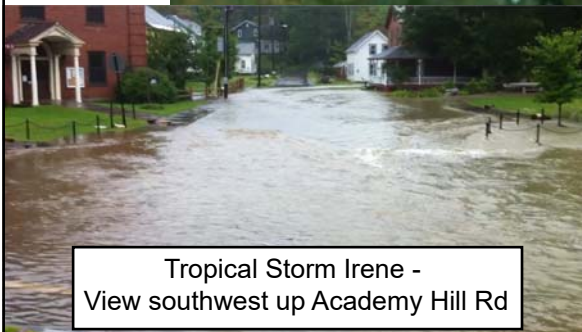
Tropical Storm Irene -
View southwest up Academy Hill Rd

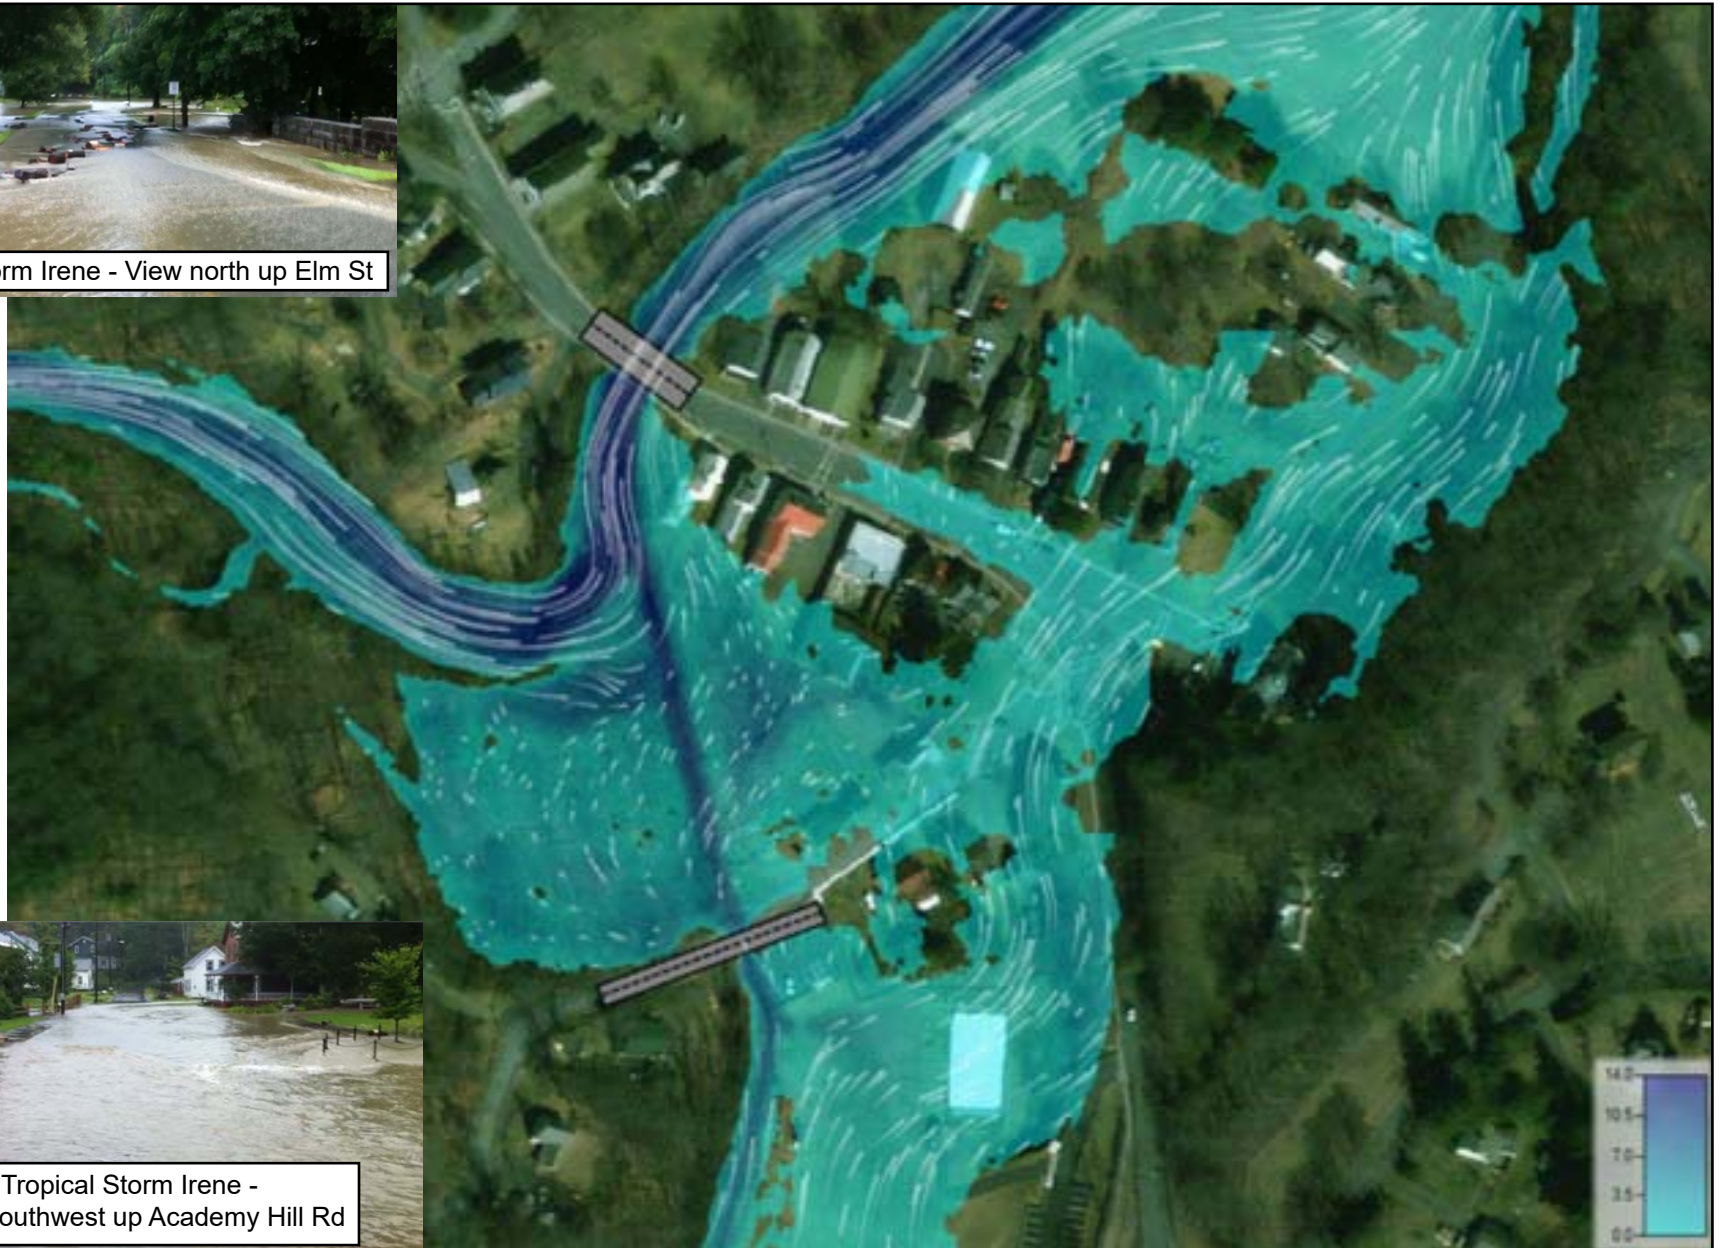
View straightened channelized reach of Pumpkin Hollow Brook from road. Note low forested floodplain that is location of previous South River stream channel and is now blocked by a boulder berm. Note athletic fields and residential development on floodplain. This area was inundated in the July 2023 floods with water flowing down Academy Hill Road and in front of the library, which gives us clues to the likely historic path of Pumpkin Hollow Brook. Optional - Walk down onto the forested floodplain and see the old swales of the historic South River and the boulder berm.

South River Walk and Watershed Tour - Stop 1. Conway center flooding. Water depth and flow paths modeled for 10-year recurrence interval event.

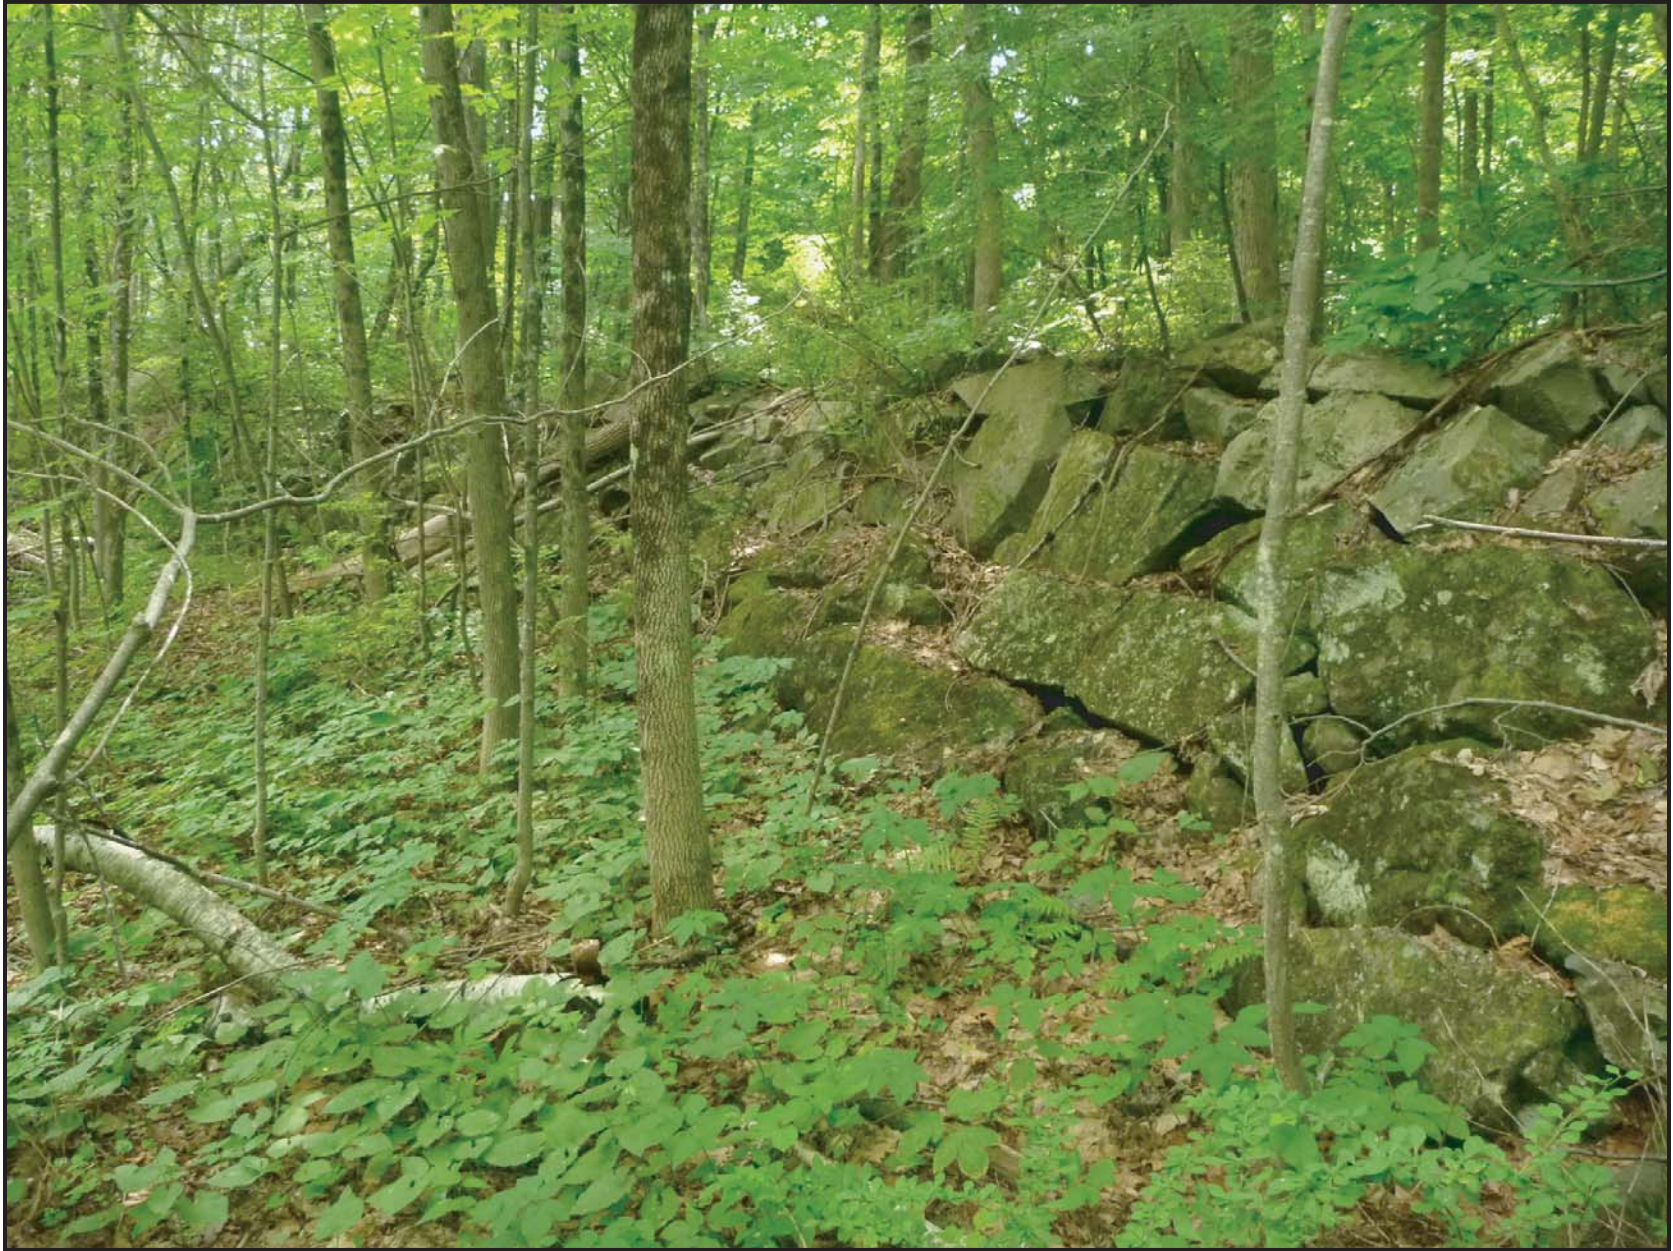
South River Walk and Watershed Tour - Stop 1. Berm constructed of large granite blocks cuts off the channel's floodplain access immediately upstream of the Main Street bridge in Conway.

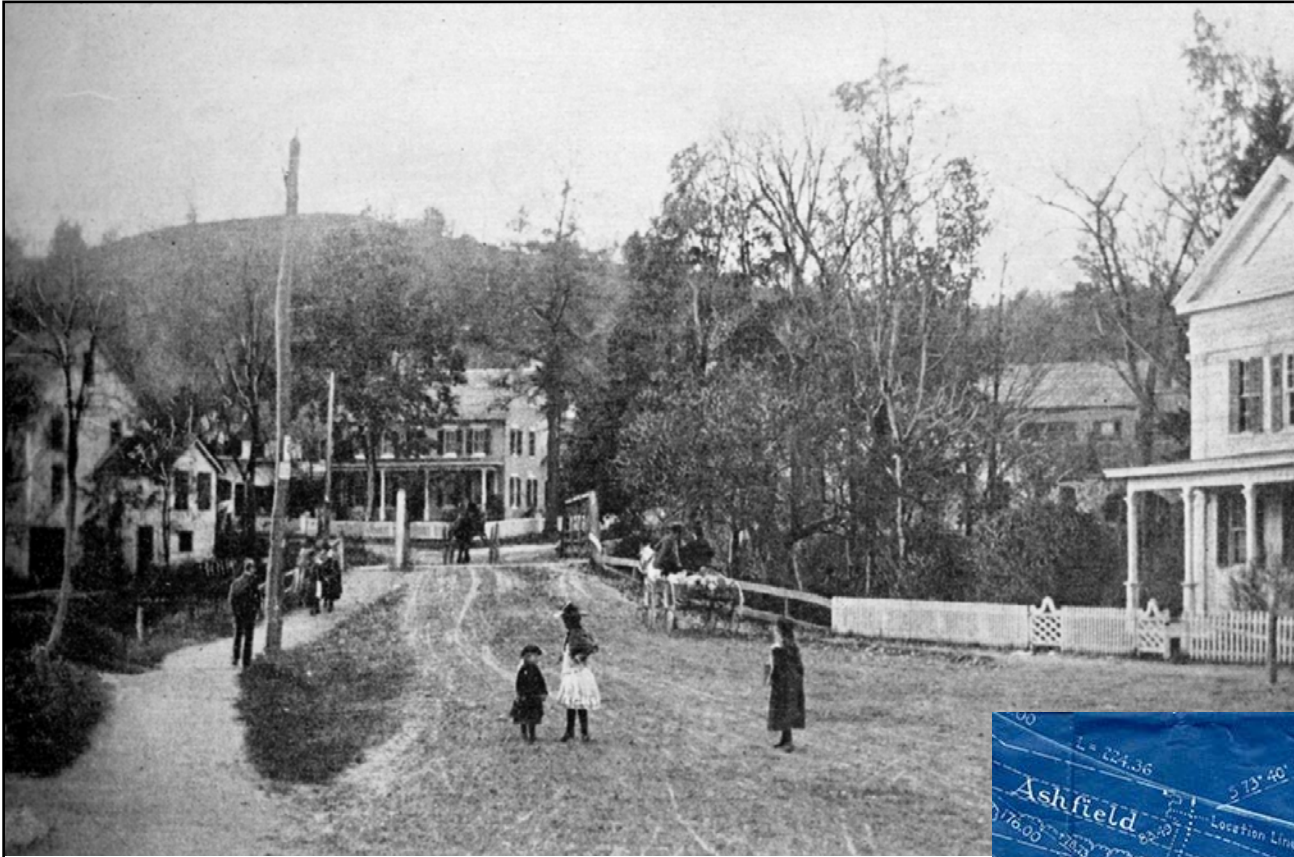
Photo of steel truss bridge, which replaced the wood trestle bridge, which was destroyed in flood of 1869 (from Picturesque Franklin, 1891, courtesy of the Conway Historical Society). The current bridge was built slightly upstream when the State Highway came through in 1926, as can be seen in the blueprints to the right. The bridge span was reduced by 31 percent from 57.1 to 39.7 feet (based on blueprints). The bridge constricts the flow during high flow events leading to increased erosion hazards.

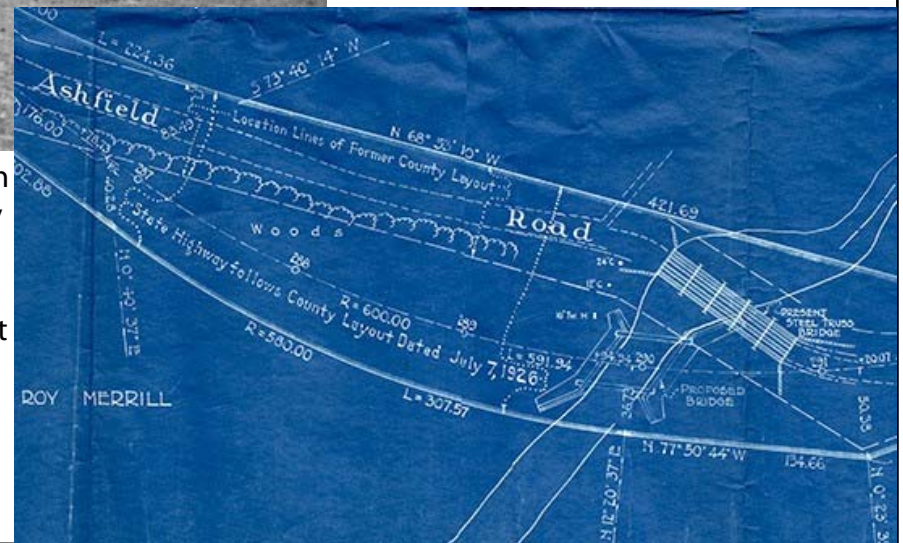
View confluence of Pumpkin Hollow Brook and South River from Main St. bridge. The Main St bridge recently underwent minor repairs and concrete work meant to extend its lifespan, which is likely nearing its end. Note boulder berm blocking floodplain and former mill channel locations. The riprap retaining wall just upstream of the bridge is at least the fourth wall to stand here. It was most-recently replaced following Tropical Storm Irene in 2011. Note the artificially straightened channel downstream of the bridge and the many houses in the stream corridor at risk of fluvial erosion.

South River Walk and Watershed Tour - Stop 2. Main Street Bridge.

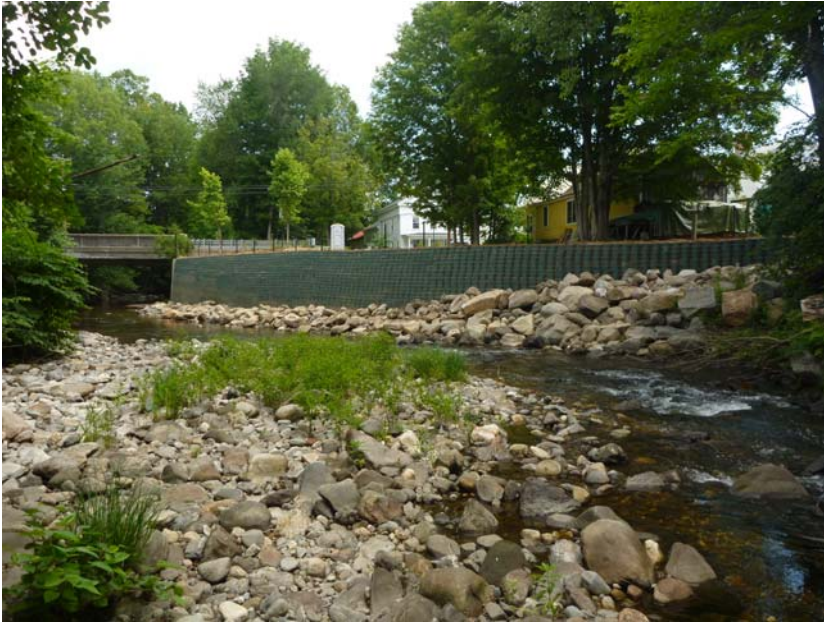
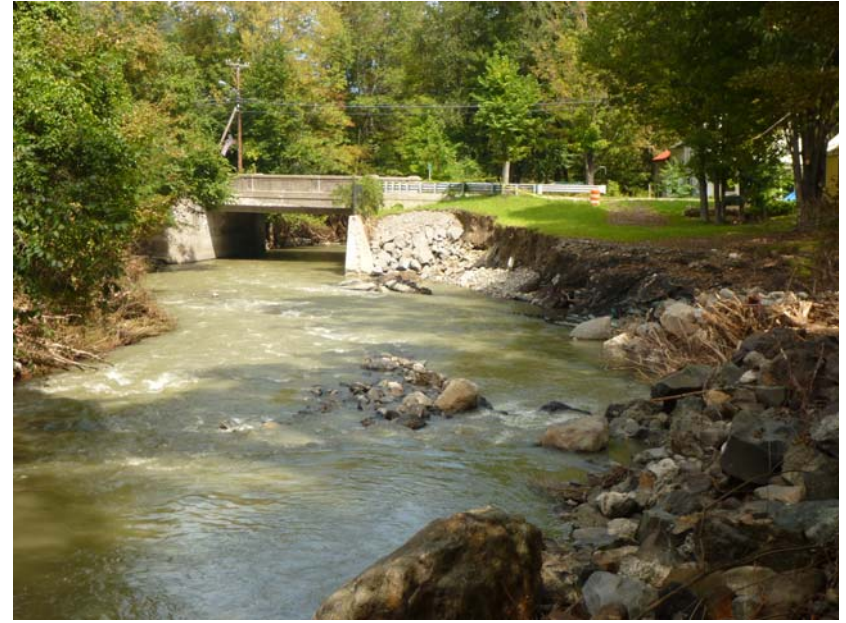
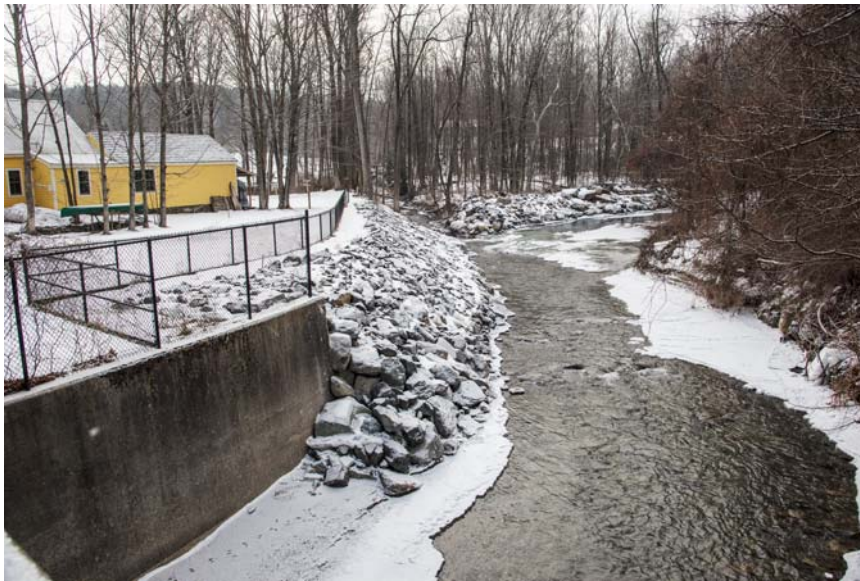
South River Walk and Watershed Tour - Stop 2. Main Street Bridge; a) geocell retaining wall completed in early August 2011 was, washed away by flooding on August 28, 2011 with c) post-flood installed riprap further constricting the channel (photo "c" courtesy of Michele Turre). The riprap wall is the fourth at the site since the mid-1980s. A concrete retaining wall washed out in 1987 to be replaced by one constructed of gabion baskets.

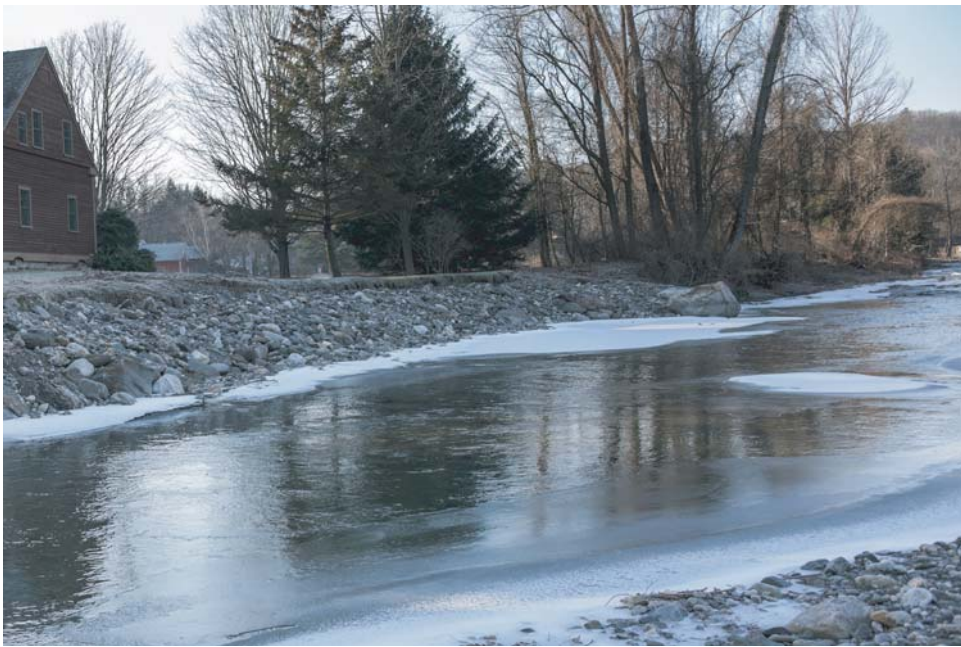
Emergency work - bank armoring following Tropical Storm Irene (courtesy of M. Turre)

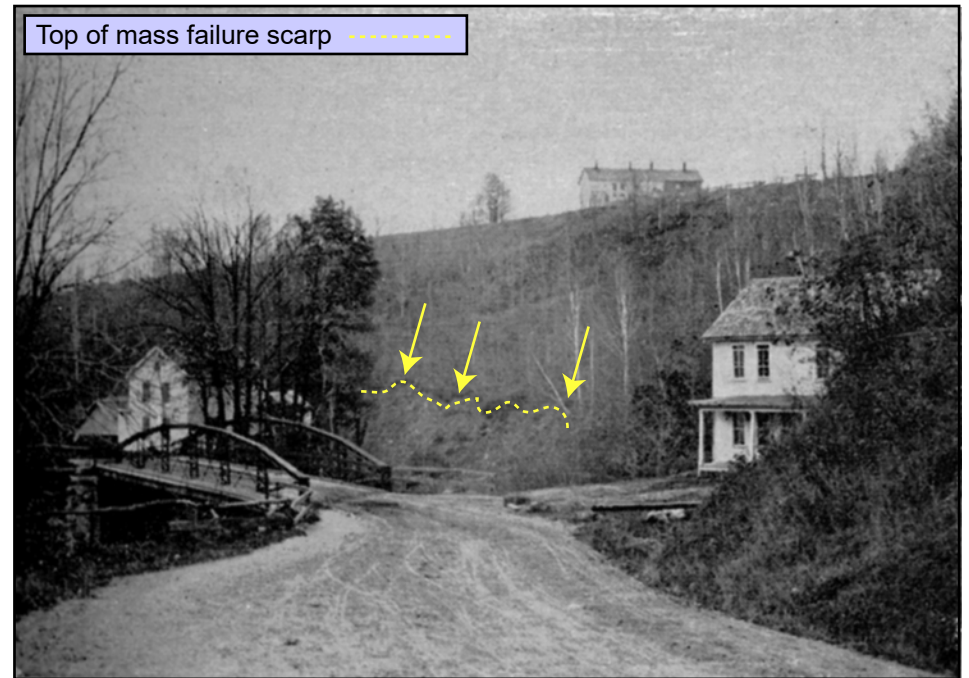
mill to power water turbines. Also note the active mass failure on the steep glacial slope across the river. This mass failure has been actively eroding off and on since at least 1890, when it can be seen on a historic photograph. Mass failures such as this represent a significant sediment source in the South River watershed.

Top of mass failure scarp Large mass failure is visible in this photo of the River Street Bridge, from Picturesque Franklin, 1891, courtesy of the Conway Historical Society). This mass failure is currently active and can be seen across the river from the mill ruins at Stop 4. The house on the right was washed out in the hurricane of 1938, the house on the left remains and was part of the Tucker and Cook mill complex. Note the relative lack of trees on the hillside in this photo from 1890.

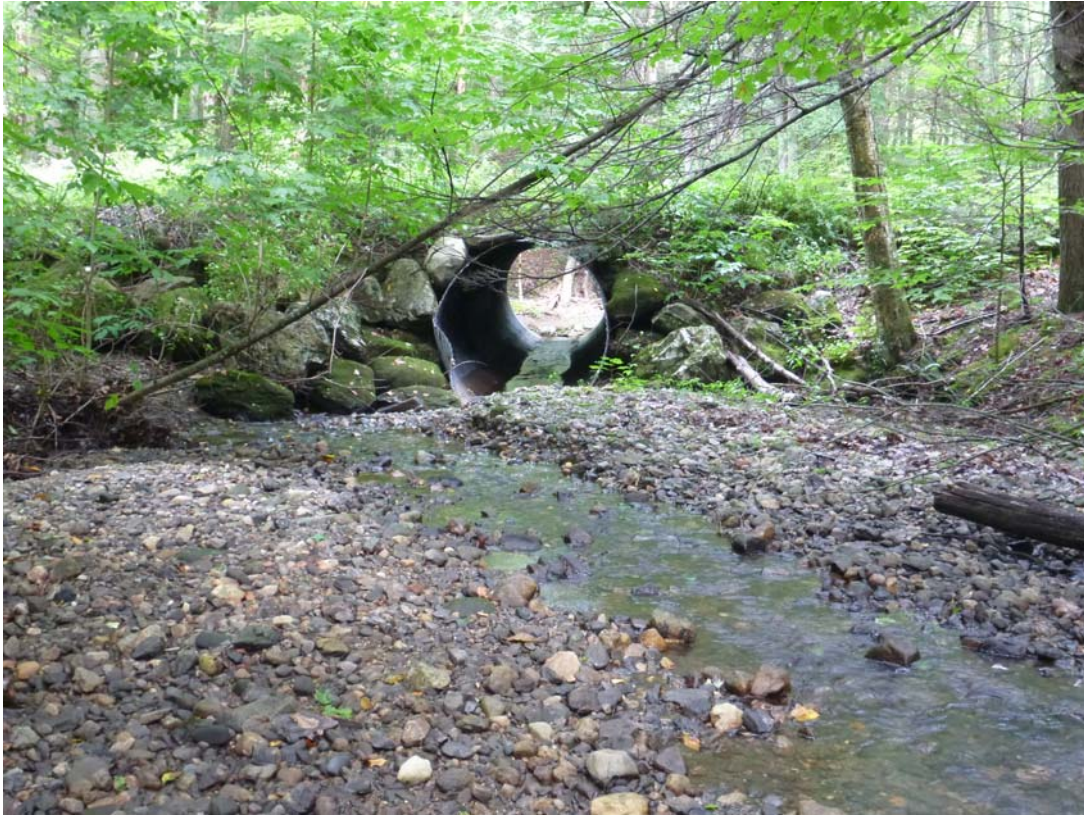
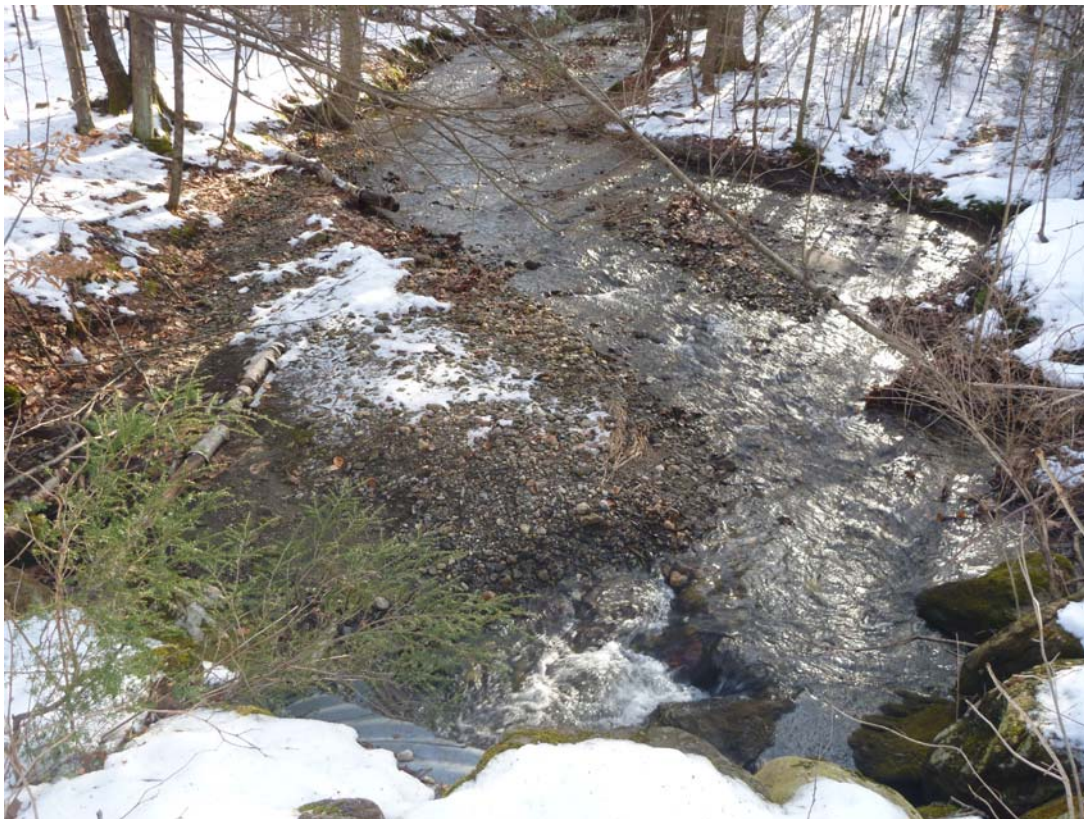
South River Walk and Watershed Tour - Stop 6. Adams Road crossing. A 2016 Fluvial Geomorphic Assessment and Corridor Planning Report documented the excess sediment deposition upstream of the undersized and incompatible culvert at Adams Rd, highlighting the downstream scour and potential undermining of the crossing.

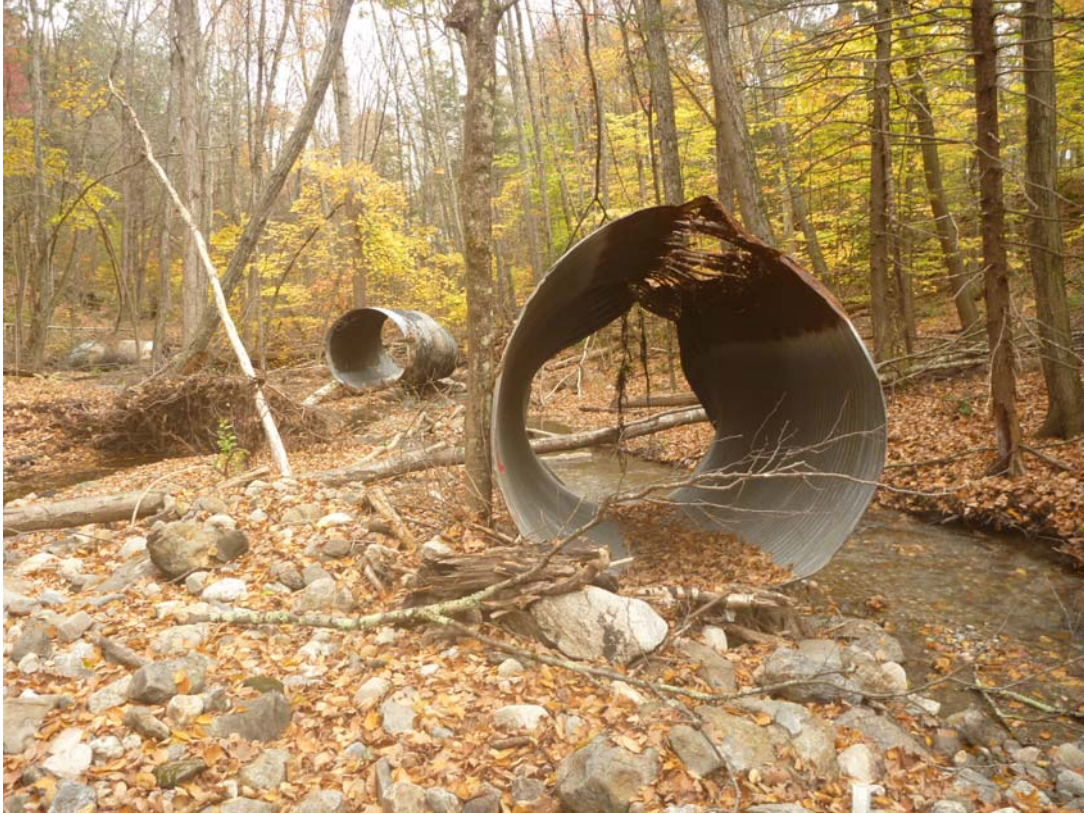
The Adams Road culvert washed out during the July 2023 floods. The failed culvert can still be seen in sections, downstream of the repaired crossing. One culvert was replaced by two smaller culverts as funding has not been made available to upsize this crossing with a more appropriate culvert or bridge. The undersized culverts are not geomorphically or hydraulically compatible with the water and sediment load of Johnny Bean Brook and represent a fluvial erosion hazard. There are two crossings along Johnny Bean Brook, the other is located downstream on Main Poland Rd, and is also significantly undersized.

South River Walk and Watershed Tour - Stop 6. Adams Road crossing. The 7-foot diameter steel culvert washed out during the July 2023 floods and a) can be seen downstream; b) this has been replaced by two smaller culverts in the repaired road crossing.

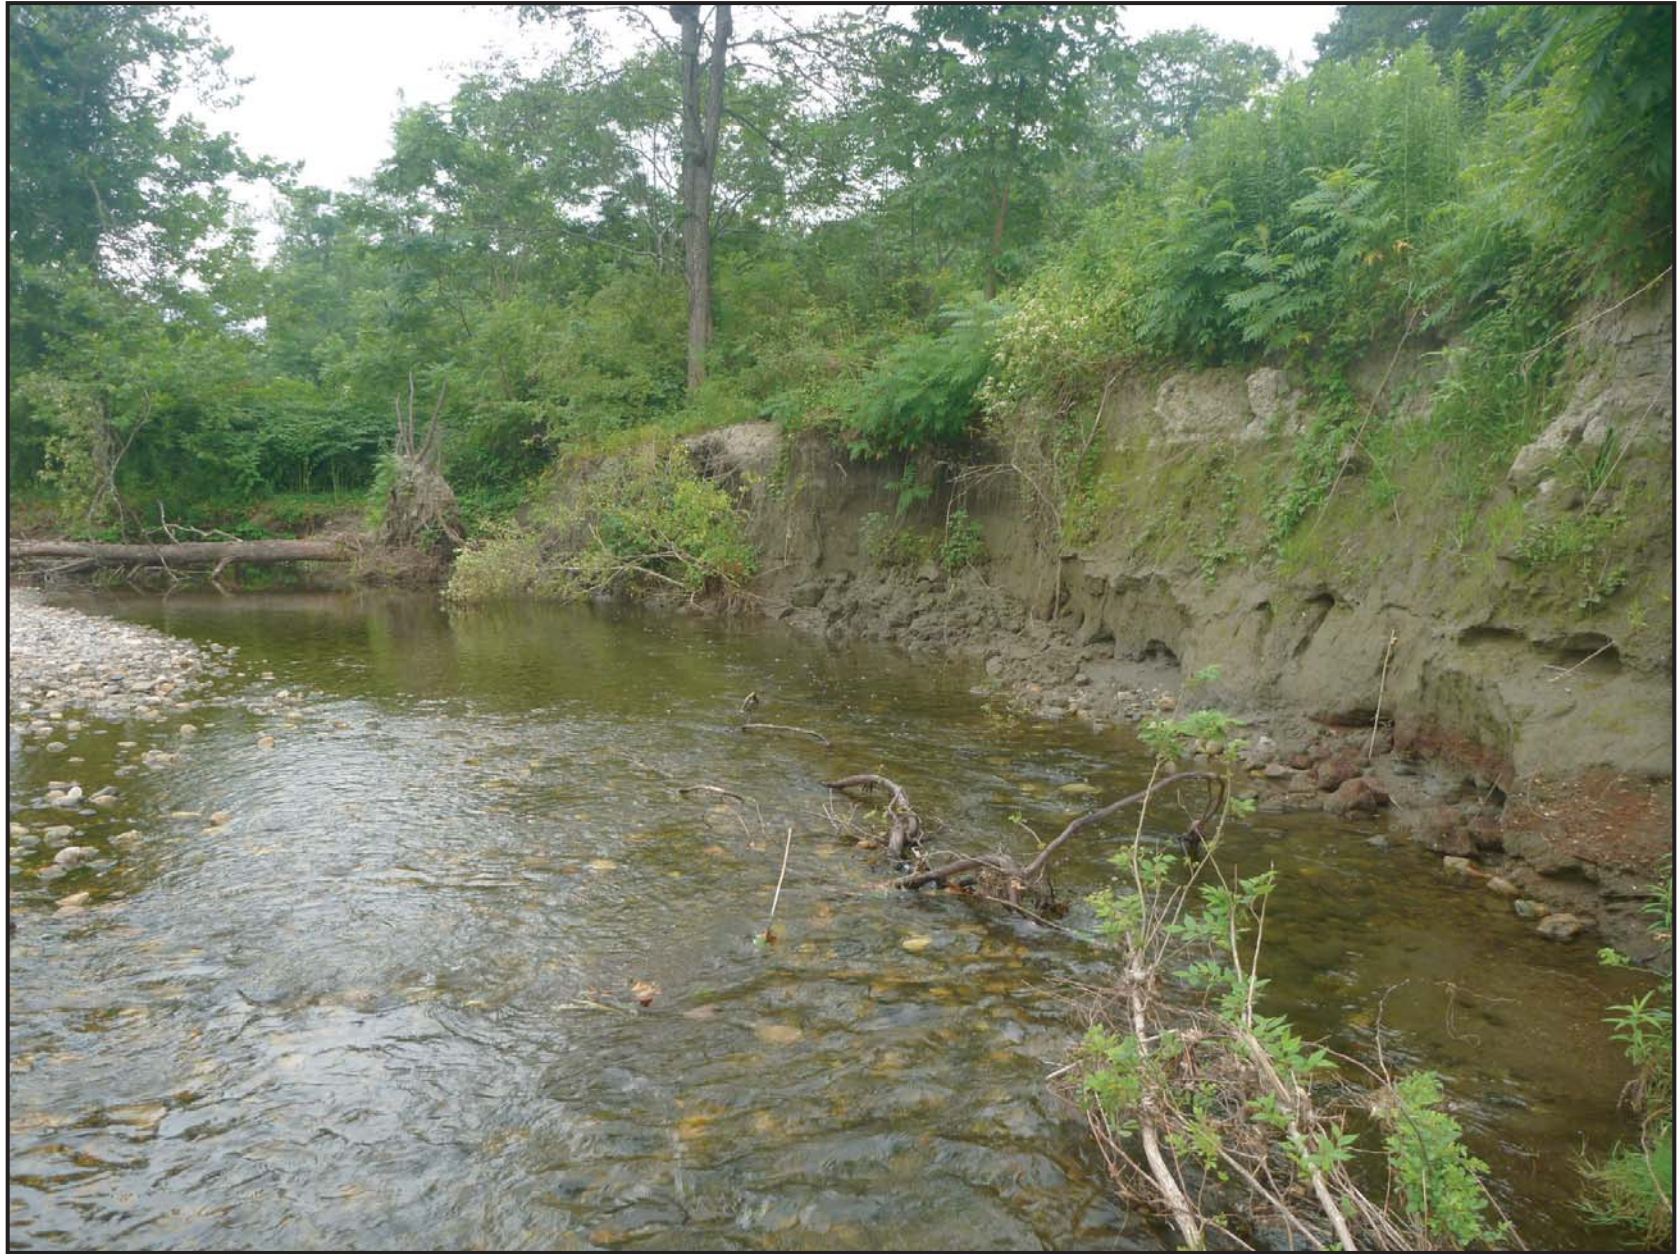
This dam was originally constructed by Tucker and Cook in 1866 to power downstream mills. Sediment sources and storage are a major story in the South River watershed, and this historic dam site continues to store a large volume of legacy sediments in its former impoundment. Readily erodible stream banks up to 10 feet high are composed of fine-grained silt and clay. The dam is gone, but its ruins and these deposits continue to influence the stream's morphology, habitat, and water quality.

South River Walk and Watershed Tour - Stop 7. Former Tucker and Cook Reservoir. Impoundment sediments along an eroding bank exposed by channel incision through a former mill pond.

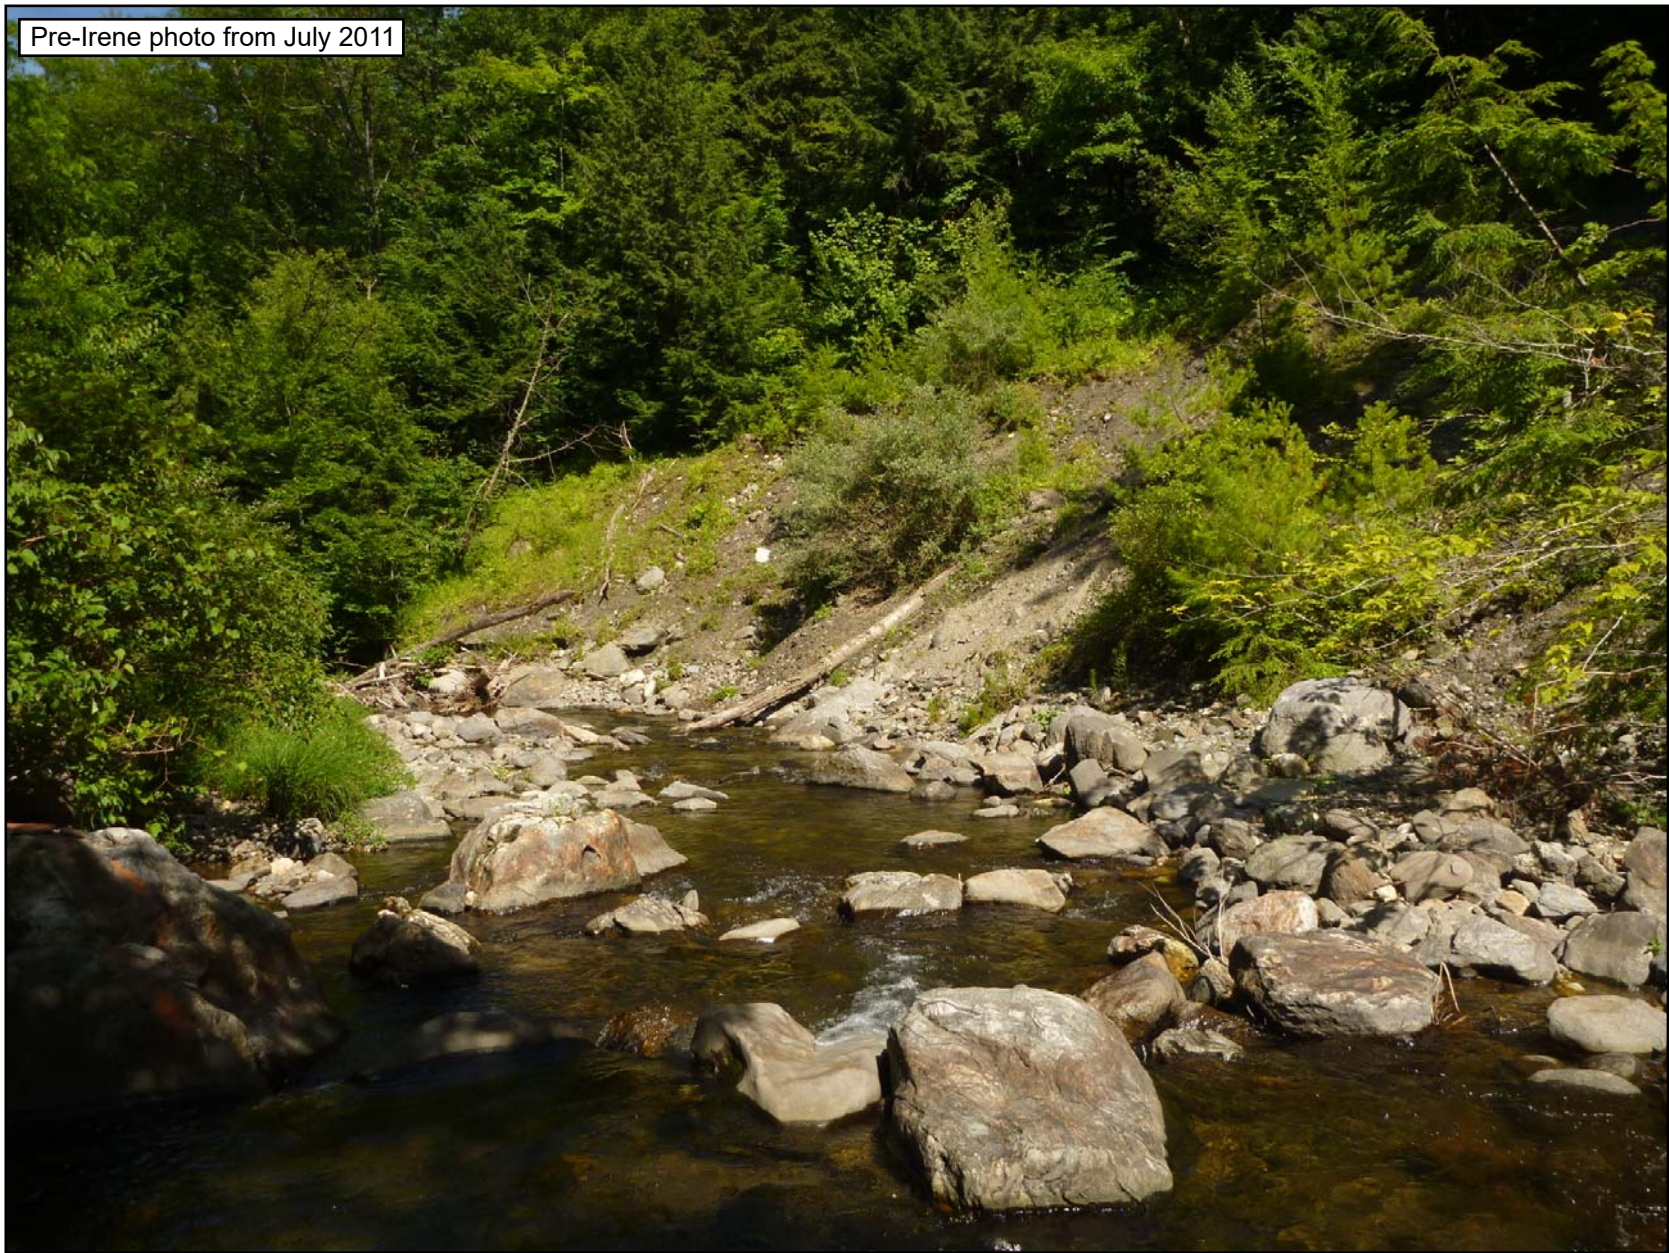
Across Rt. 116 a mass failure in clay-rich glacial till represents a large point source for both coarse and fine sediment, impacting water quality and sediment-loading downstream. This is just one of several large mass failures along the South River, contributing to the erosion hazards that Conway is experiencing.

South River Walk and Watershed Tour - Stop 8. Large mass failures often occur where the artificially straightened channel impinges upon high banks of glacial sediment leading to unstable slopes. These failures can remain active for many years, acting as a point source for sediment loading and water quality impairments.
