**SOUTH
RIVER**
WATERSHED
A SELF-GUIDED TOUR

The South River Watershed Tour was originally led by Fluvial Geomorphologist Nicolas Miller on November 18, 2023. This guidebook replicates the tour for anyone who is interested in learning more about current conditions of the watershed. Three of the stops can be seen by walking around Conway Center, and the rest will require driving or biking a bit farther.

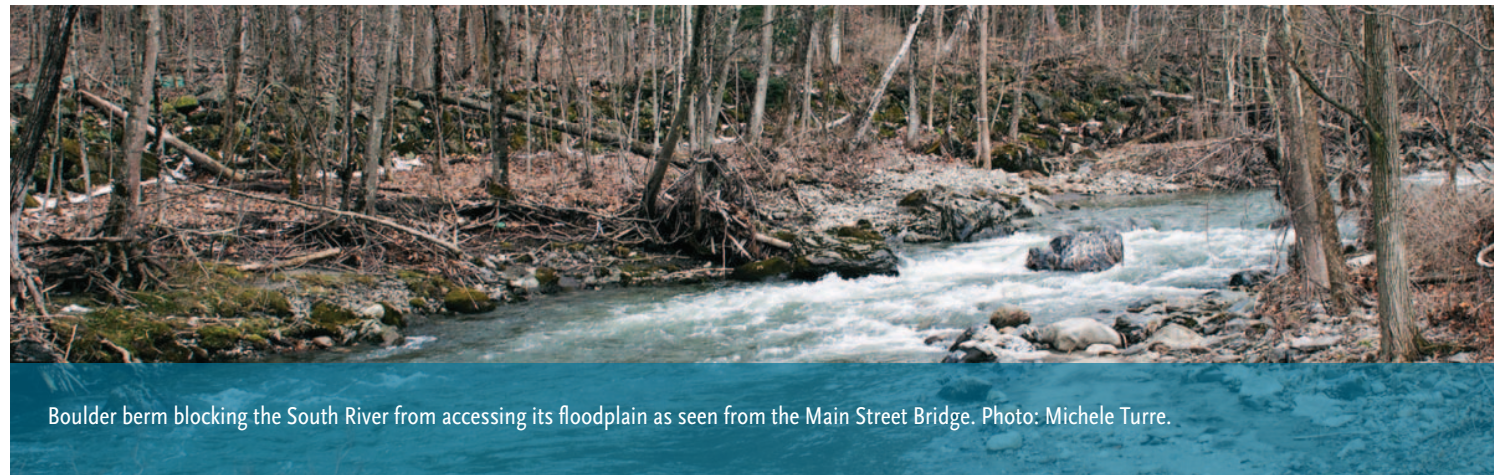
Boulder berm blocking the South River from accessing its floodplain as seen from the Main Street Bridge. Photo: Michele Turre.

Sometime after 1939, in response to flooding during hurricanes in 1936 and 1938, the Town constructed a system of dikes and berms to keep the South River out of the lowlands and prevent the flooding of buildings along Main Street. The South River was forced into a sharp turn just upstream of the Main Street Bridge, and a new straight channel was dug for Pumpkin Hollow Brook. This map shows the original course of the South River, compared to how the South River and the Pumpkin Hollow Brook flow today.

meant to extend its lifespan, which is likely nearing its end. Note the boulder berm (shown in bottom photo, page 2) blocking floodplain and former mill channel locations. The riprap retaining wall just upstream of the bridge is at least the fourth wall to stand here. It was most recently replaced following Tropical Storm Irene in 2011. Note the artificially straightened channel downstream of the bridge (across the street) and the many houses in the stream corridor at risk of fluvial erosion.

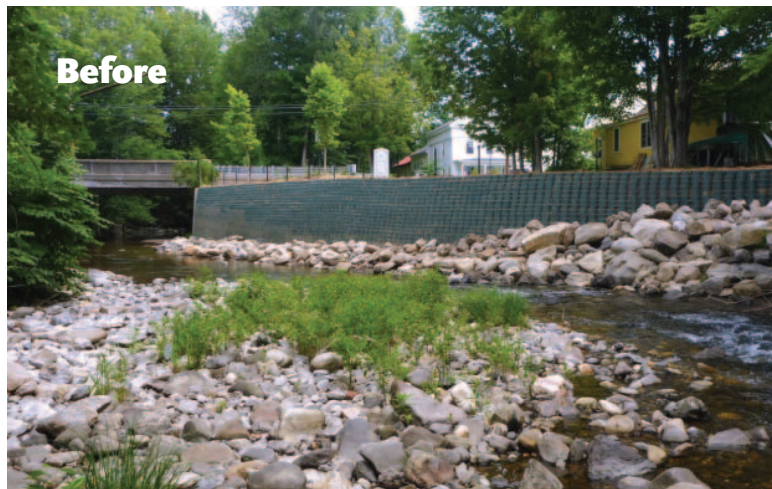
Before

A GeoCell retaining wall that was installed only a couple of weeks before Tropical Storm Irene hit Conway in August 2011.

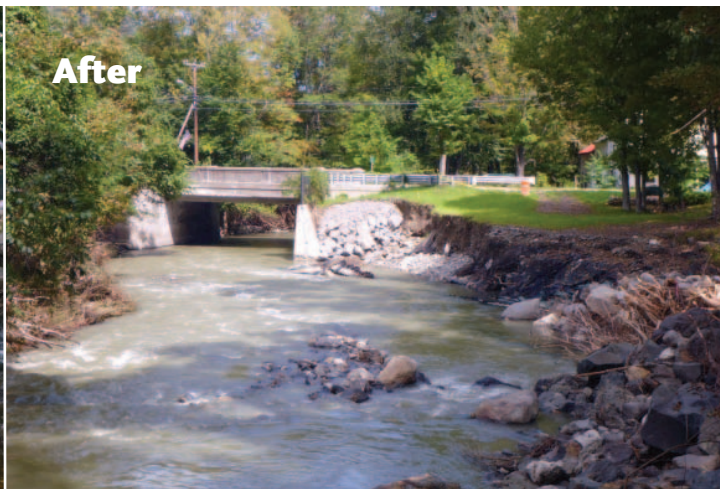
After the retaining wall washed out emergency rip-rap repairs were made that narrowed the river channel. Photos: Nicolas Miller.

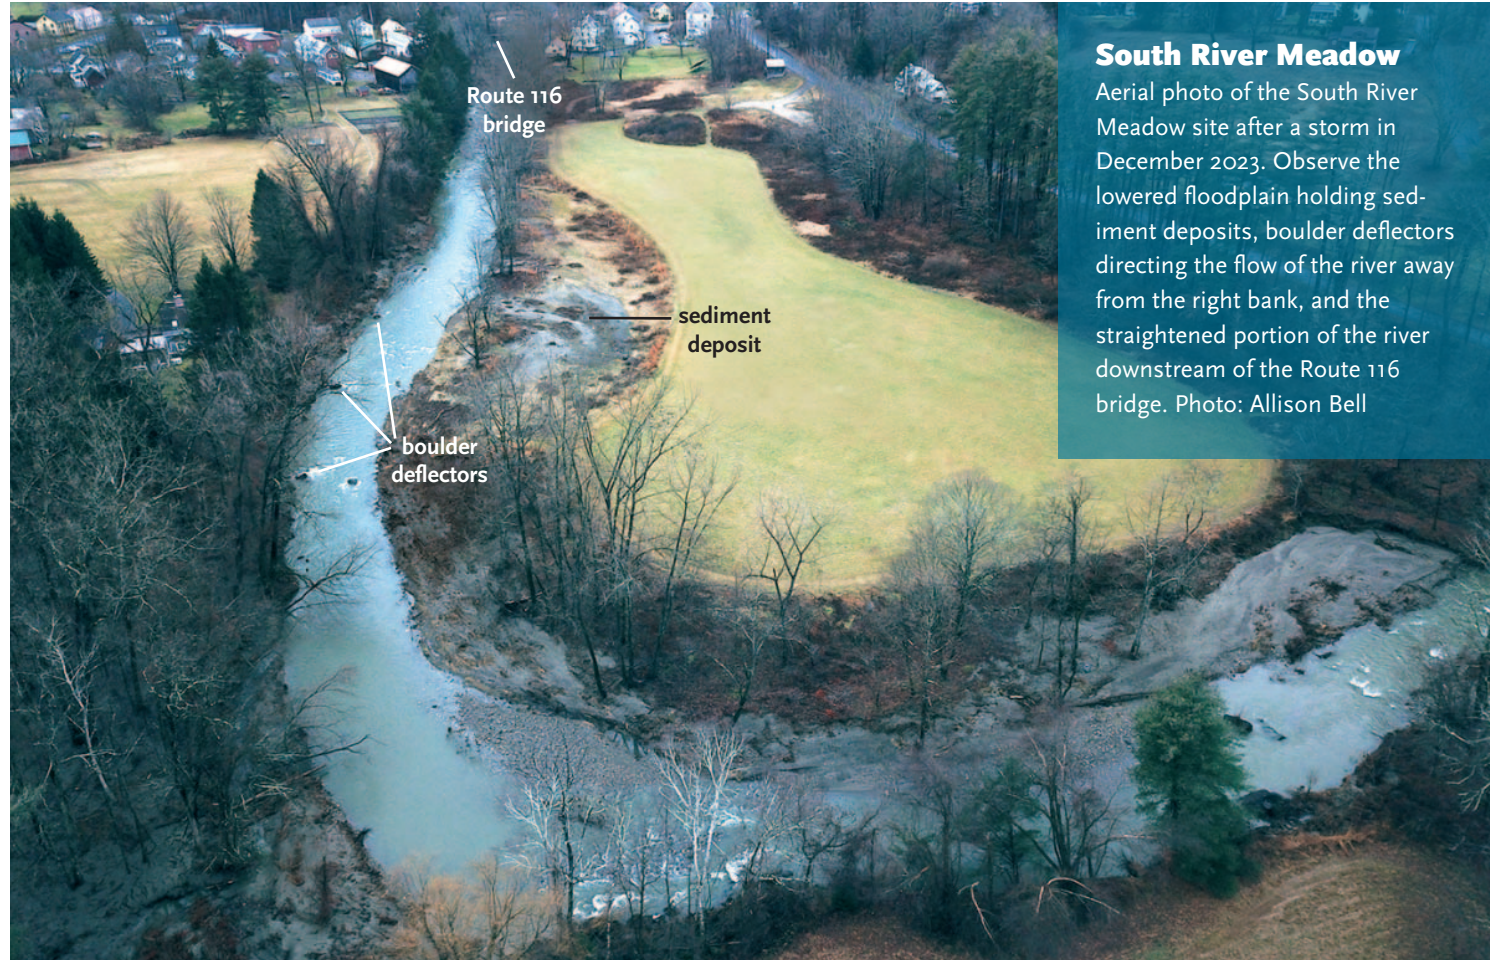
South River Meadow
Aerial photo of the South River Meadow site after a storm in December 2023. Observe the lowered floodplain holding sediment deposits, boulder deflectors directing the flow of the river away from the right bank, and the straightened portion of the river downstream of the Route 116 bridge. Photo: Allison Bell

The town-owned South River Meadow is the site of a river restoration project completed in September 2016. The project was a collaborative effort between the Town of Conway, Franklin Regional Council of Governments, Field Geology Services, New England Environmental, and Weston & Sampson. A portion of the floodplain was lowered to reconnect the channel to its floodplain and provide flood storage and a site for sediment deposition. Note the recently deposited sand sheets and rafted debris; the river inundated this floodplain three times in July 2023, and at least 14 times since the project was completed in 2016. A series of boulder deflectors

along the right bank deflect flow from a home along the previously eroding bank. Note the sediment deposition along the right bank between the structures. Large wood and boulders used in the restoration provide many habitat benefits including carving and maintaining pools, providing cover, increasing flow complexity, sorting and storing sediment and narrowing the stream channel.

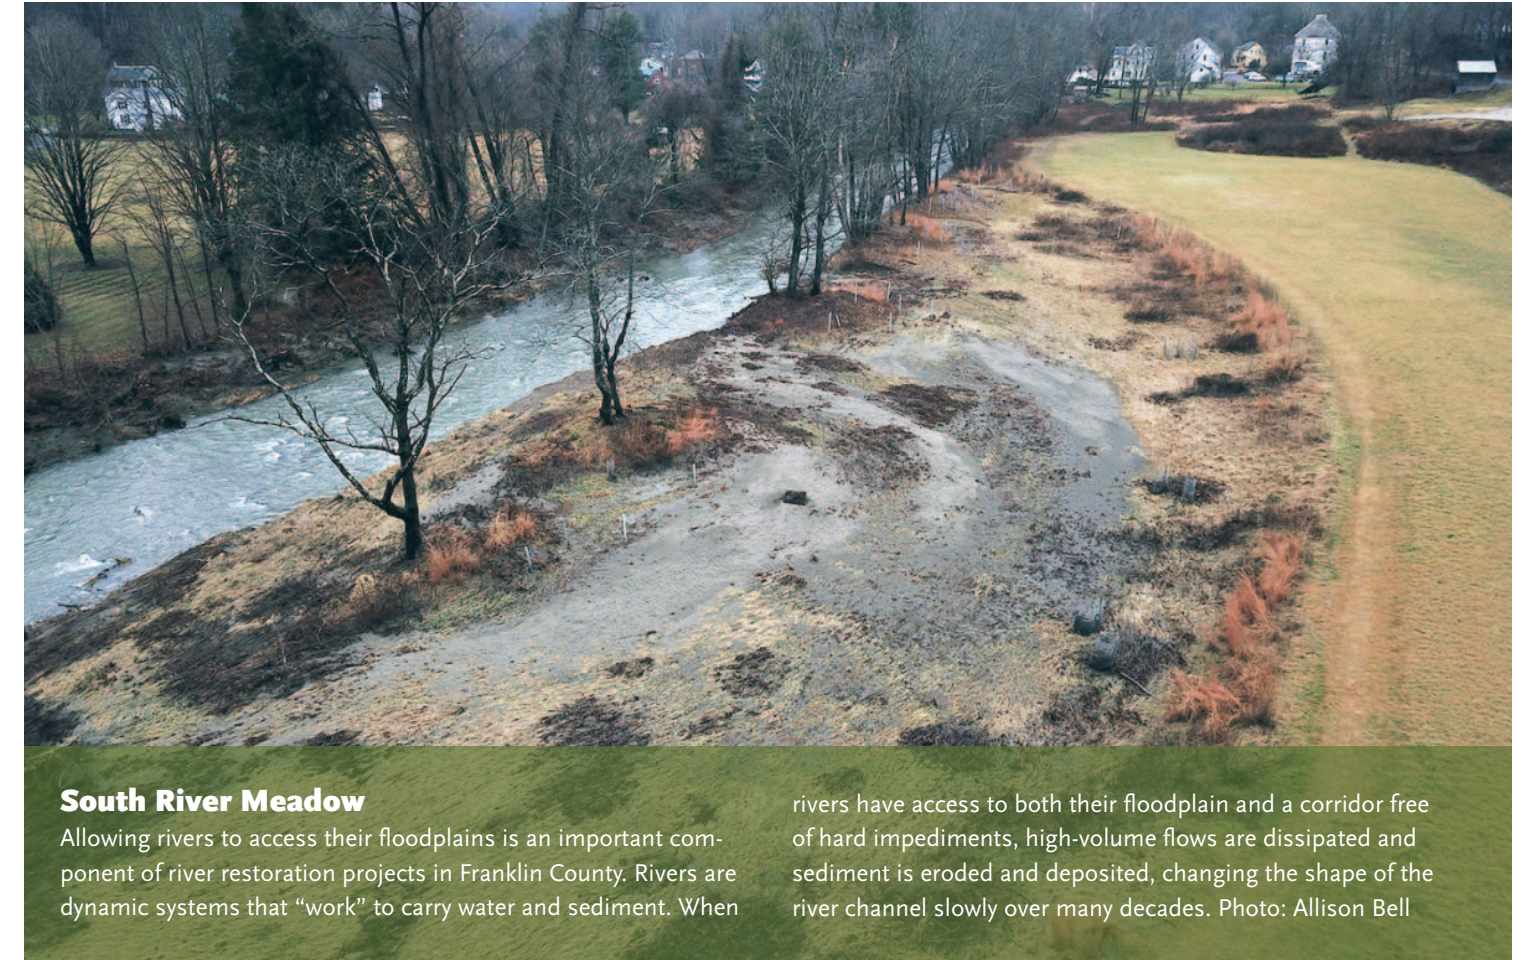
South River Meadow
Allowing rivers to access their floodplains is an important component of river restoration projects in Franklin County. Rivers are dynamic systems that “work” to carry water and sediment. When rivers have access to both their floodplain and a corridor free of hard impediments, high-volume flows are dissipated and sediment is eroded and deposited, changing the shape of the river channel slowly over many decades. Photo: Allison Bell

How can we protect and enhance the areas along the South River? The South River Meadow project is also known as a “floodplain reconnection” project because it allows the South River to access its floodplain. Before this project, during a storm event the river would rush by, causing erosion and carrying sediment downstream. There are many areas along the South River where the river can, and does access its floodplain. What are some options we have to preserve those critical connections?

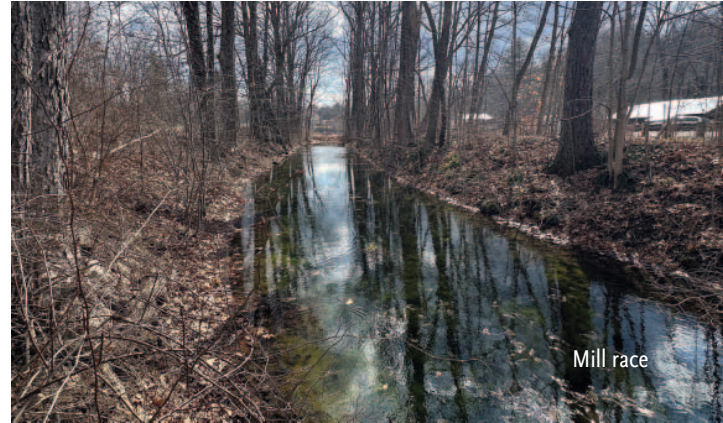
From the parking lot at St. Mark's Church, walk down the hill to view the mill race that once carried water to the Delabarre Woolen Mill, where Orchard Equipment Supply Co. (OESCO) stands today. Across Route 116 a channel-spanning log is all that can be seen of the historic mill dam that once fed this canal.

Mill race

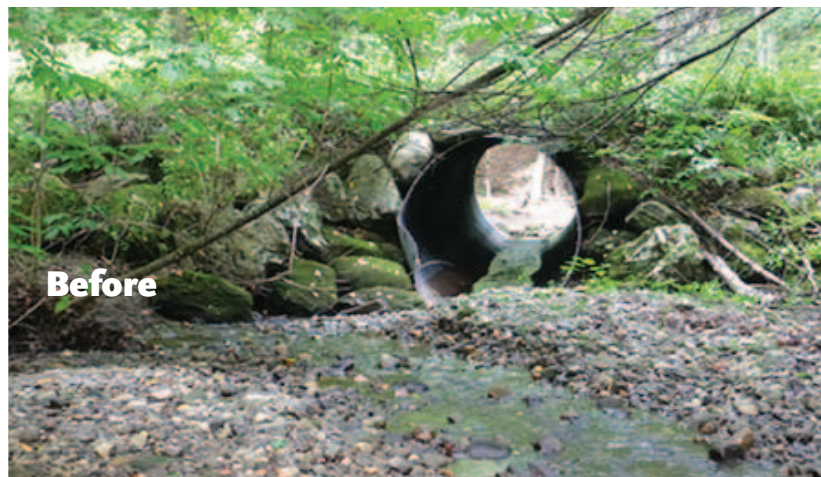
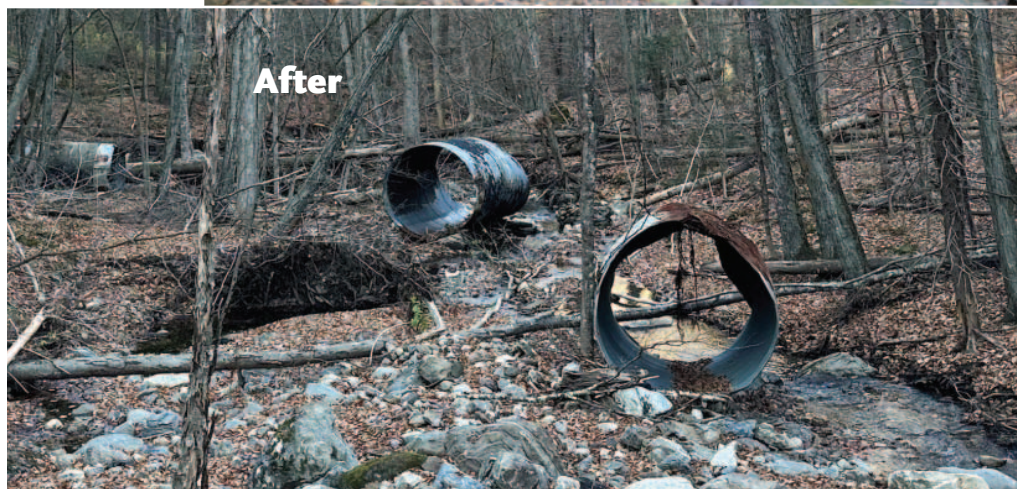
The Adams Road culvert washed out during the July 2023 floods. As of November 2023, the failed culvert can still be seen in sections, downstream of the repaired crossing. The previous seven-foot-wide culvert was replaced by two smaller culverts as funding has not been made available to upsize this crossing with a more appropriate culvert or bridge. The undersized culverts are not geomorphically or hydraulically compatible with the water and sediment load of Johnny Bean Brook and represent a fluvial erosion hazard. There are two crossings along Johnny Bean Brook, the other is located downstream on Main Poland Road, and is also significantly undersized.

Top: Adams Road culvert, before the July 2023 storms. Bottom: Adams Road culvert washed out into three pieces, after the July 2023 storms.

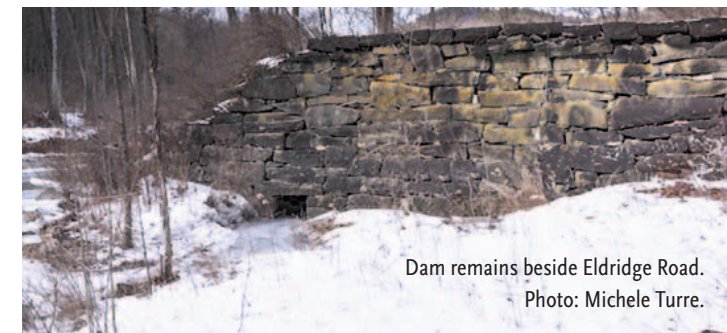
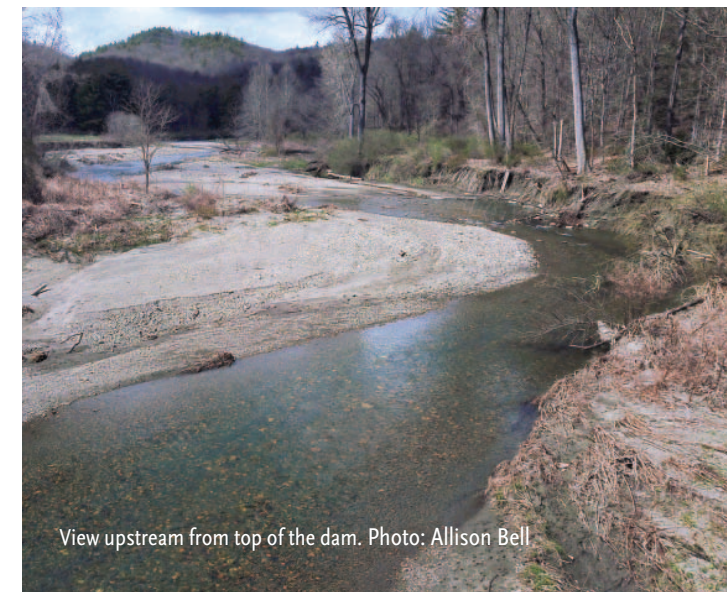
This dam was originally constructed by Tucker and Cook in 1866 to power downstream mills. Sediment sources and storage are a major story in the South River watershed, and this historic dam site continues to store a large volume of legacy sediments in its former impoundment. Readily erodible stream banks up to 10 feet high are composed of fine-grained silt and clay. The dam is gone, but its ruins and these deposits continue to influence the stream's morphology, habitat, and water quality.

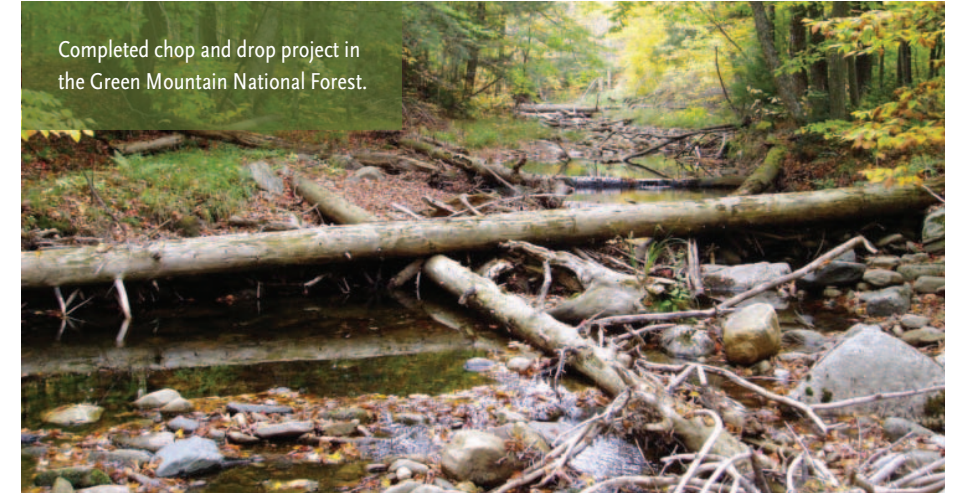
Completed chop and drop project in
the Green Mountain National Forest.

Chop and drop projects are a part of the engineering designs. Adding more wood to the upland, forested tributary streams in the South River watershed will slow and spread stormwater, recharge the aquifer, and help protect downstream infrastructure (roads, culverts, etc.) from excessive amounts of stormwater runoff, sediment loading and flooding. These projects have been successful in providing flood resiliency and habitat enhancement in forested reaches, including H.O. Cooke State Forest in Heath and throughout New England.

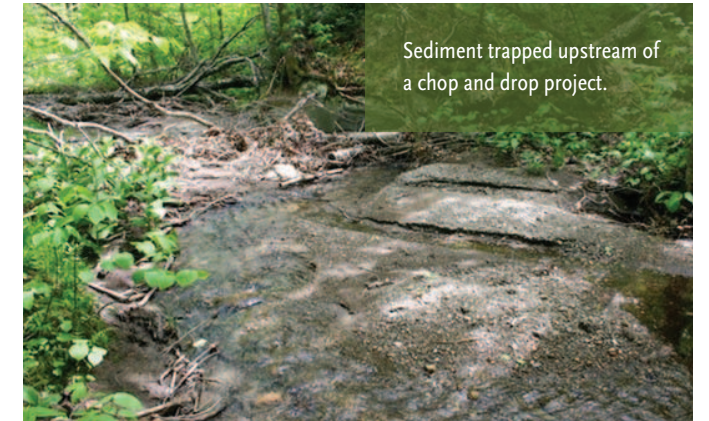
Sediment trapped upstream of
a chop and drop project.

A large sediment load may also reduce the amount of light available to organisms they need to grow. Depending on where the erosion occurs, sediment loads can also carry pathogens and/or pollutants, which are detrimental to aquatic life and human health. The South River has many points where erosion is occurring, and the straightened reaches allow the river to wash sediment quickly through the system. One potential solution to catch sediment from eroding banks is to install “chop and drop” (also known as wood addition) projects.

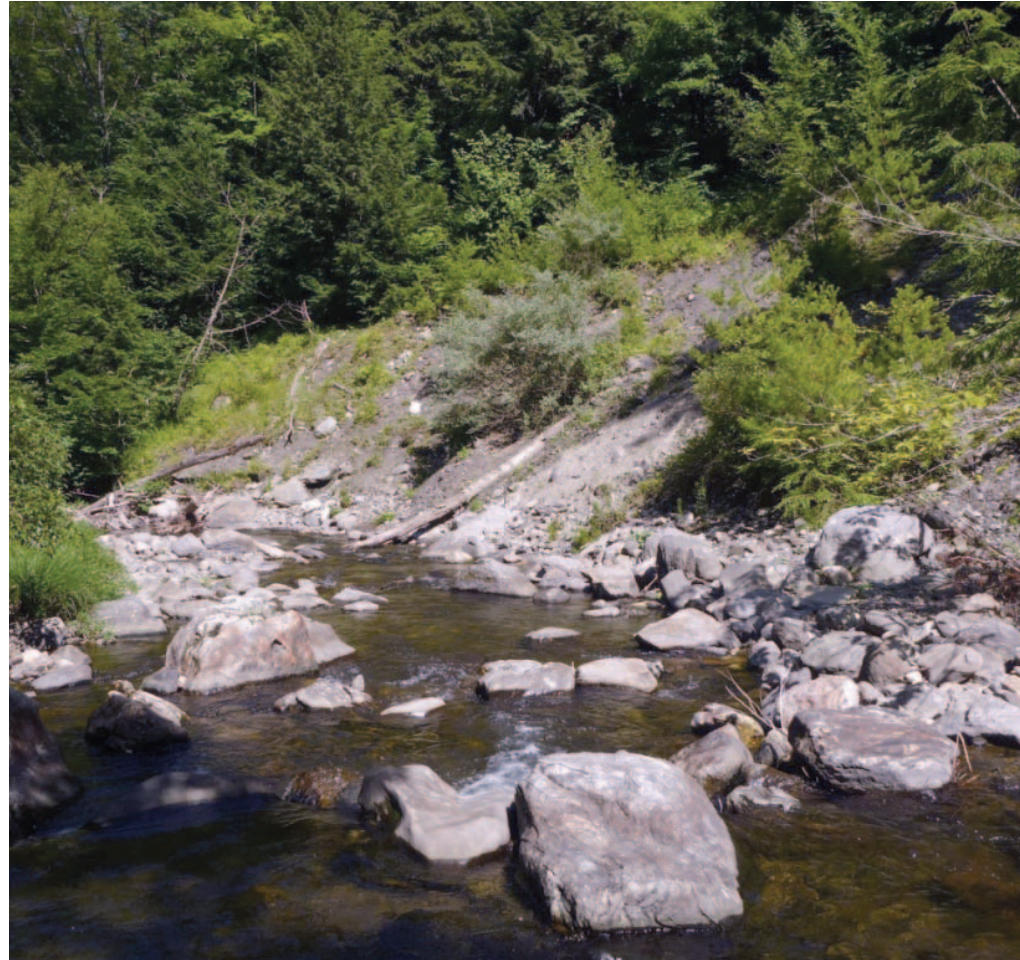
This photo is from pre-Tropical Storm Irene in 2011. Large mass failures often occur where the artificially straightened channel impinges upon high banks of glacial sediment leading the unstable slopes. These failures can remain active for many years, acting as a source for sediment loading and water quality impairments.
