Memo

Date: October 30, 2023

Re: Upper Baptist Hill Rd, Pine Hill Rd, Baptist Hill Rd Drainage Assessment

Existing Stormwater Drainage Infrastructure Assessment Pine Hill Road Neighborhood, Conway MA

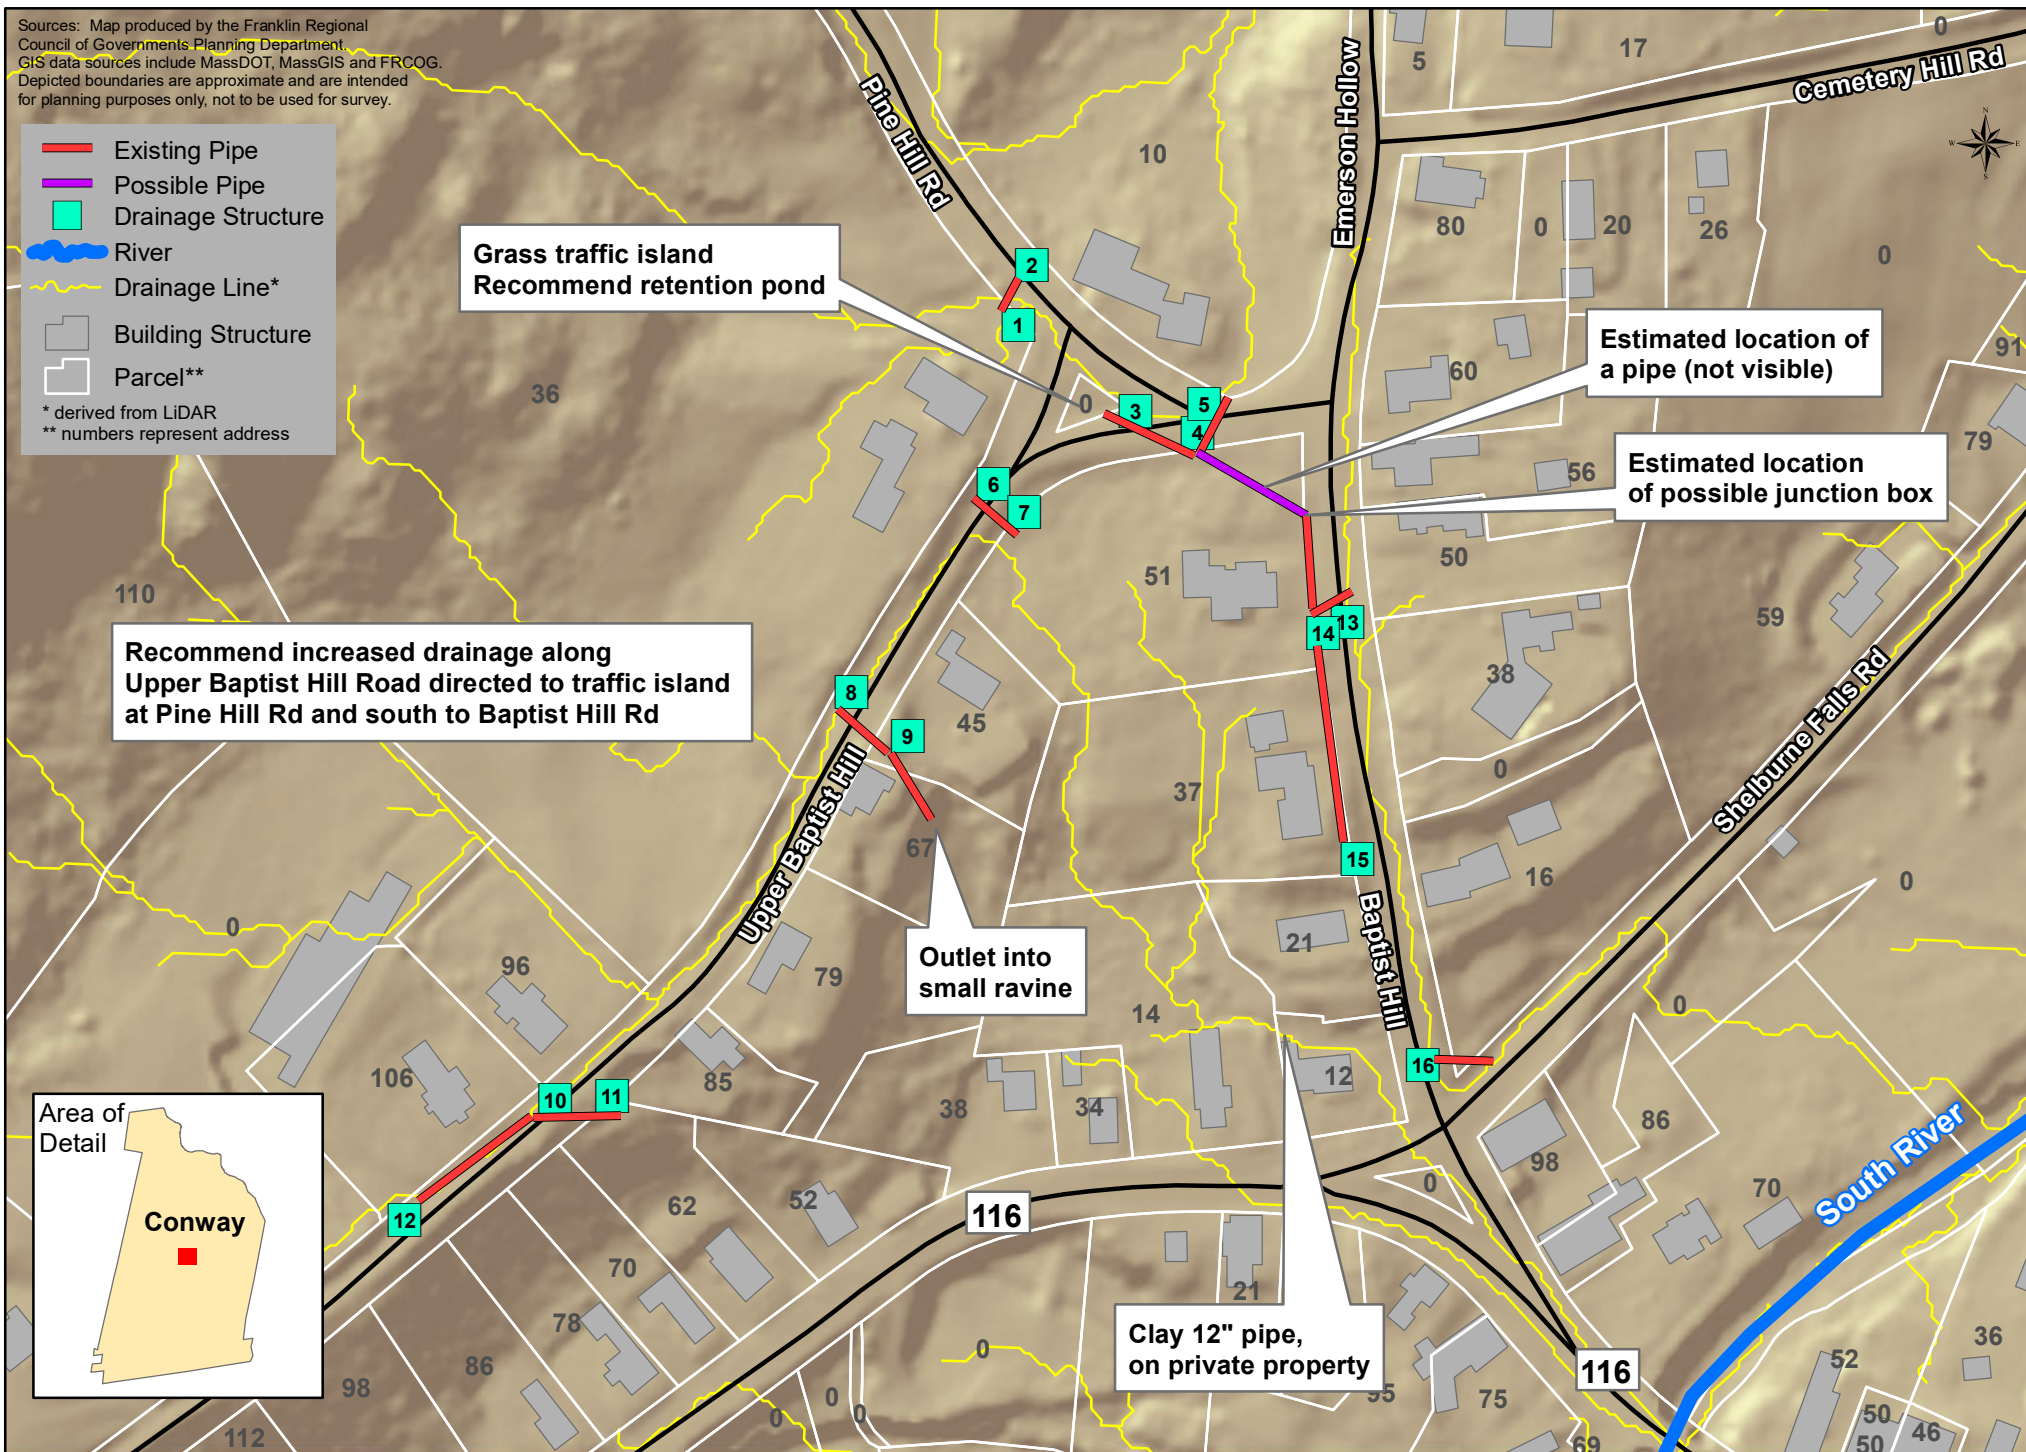
Overall, FRCOG staff found only 16 drainage structures in the study area. Not only is this an insufficient number for the size of the drainage area and terrain, but many of the structures are also not sized large enough. There are also gaps in connecting drainage structures causing storm water to rapidly flow over the land rather than being channeled through culverts and drop inlets. In addition, there are locations in which culvert pipes and/or junction boxes are suspected to be crushed or non-existent. A GIS analysis using LiDAR data¹ and “right sizing”² calculations found that many of the culverts are not large enough to accommodate the water flowing from the sub-watersheds in the area. The FRCOG also conducted a GIS analysis showing estimated drainage areas for stormwater to help determine where stormwater would most likely flow during heavy rain events (see map).
